Preliminary Assessment
Big River Mine Tailings
Desloge, St Francois County, Missouri
TDD #F-07-8711-039 PAN #FM00616PA
Site #Y60 Project #001
Submitted to Paul E Doherty, RPO
Task Leader Robert Overfelt, E & E/FIT
Superfund Contact Gene Gunn
Date May 17, 1988

TABLE OF CONTENTS

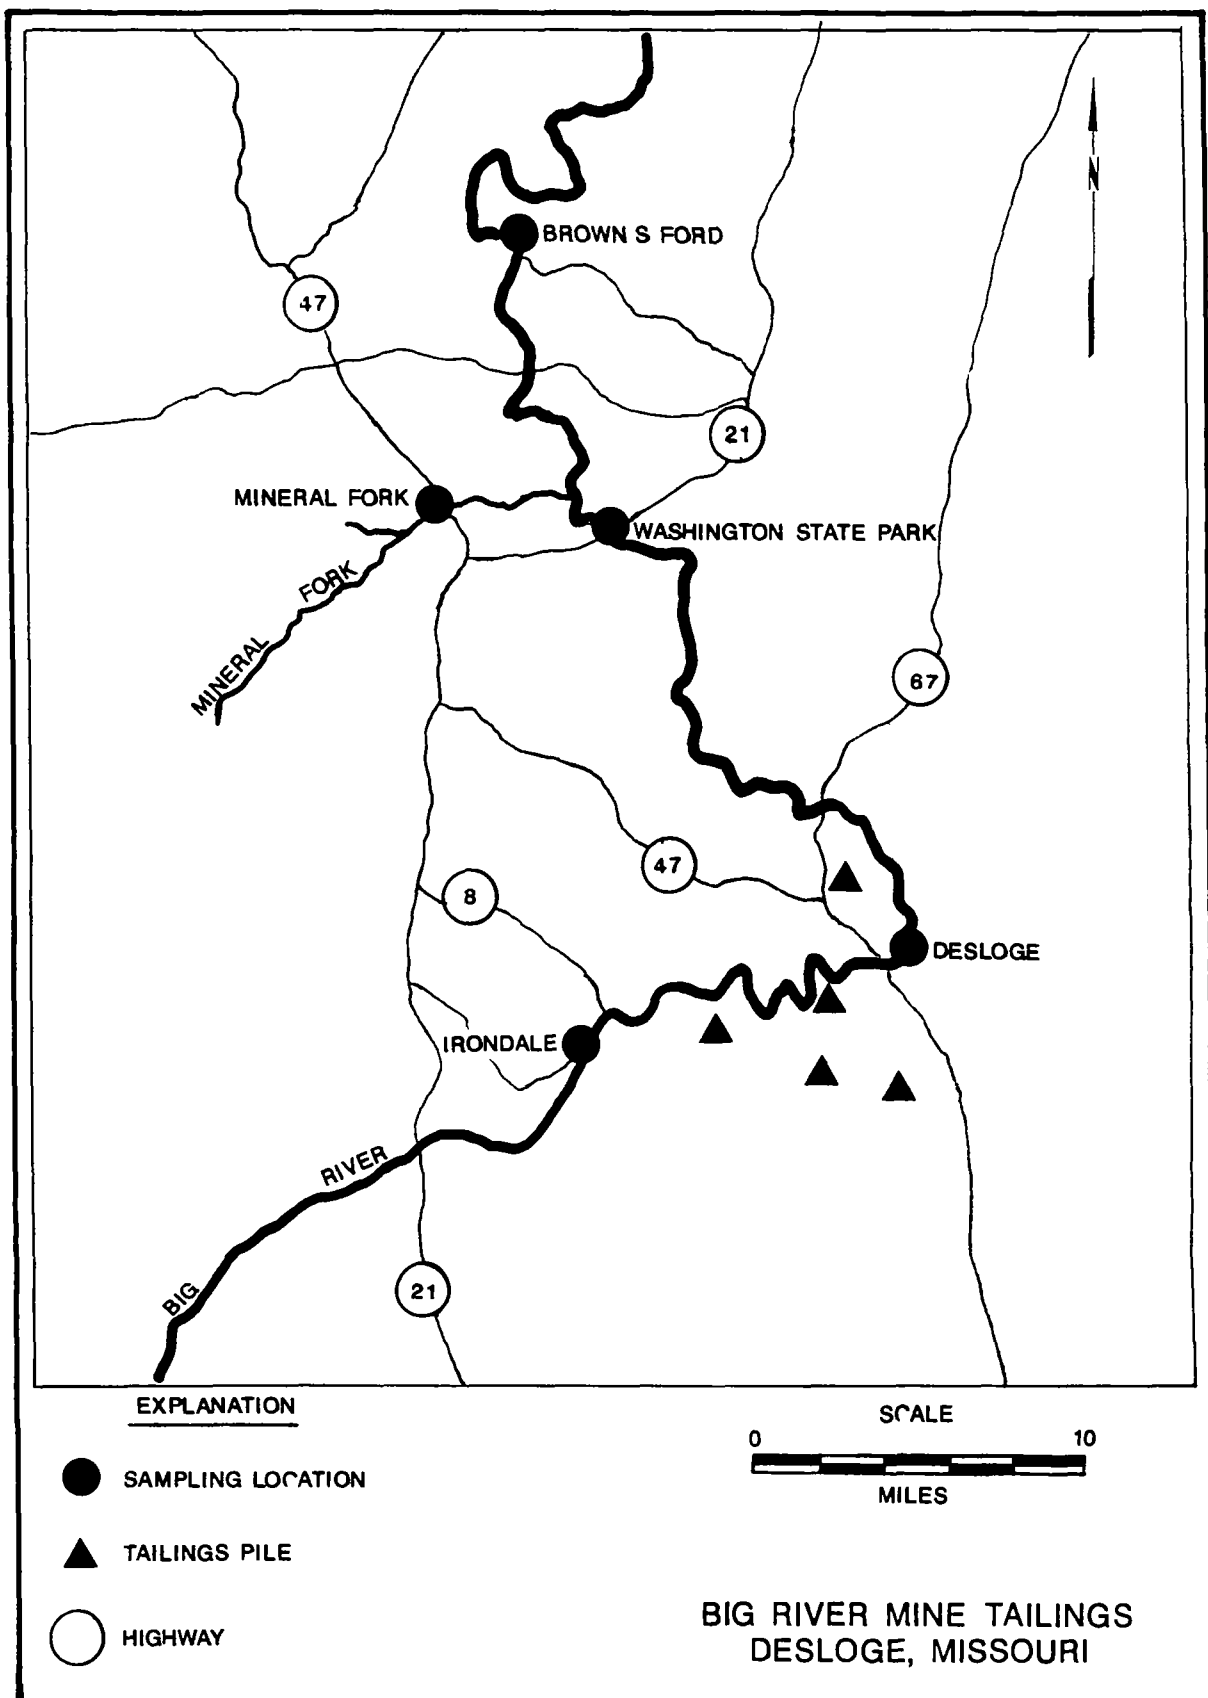
Sediment samples were collected from corresponding locations on the Big River. Total sediment Pb concentrations were highest at Desloge (2215.0 $\mu\text{g/g}$) and tended to decrease with distance downstream. This value is similar to the Pb content found in the tailings at the Desloge pile (Appendix D). Total Pb concentration was lowest (49.6 $\mu\text{g/g}$) at Irondale. Concentration at Mineral Fork were substantially higher than at Irondale, though were lower here than at other locations. This is probably attributable to the past Pb mining or on-going barite mining activities in the Mineral Fork watershed. These sampling results show how the mine tailings had affected the benthic zone of the Big River at the Desloge mining pile and for several miles downstream (Table 3) (Ref 16).
